# NORTH WEST COAST NEWS

**JULY 2014  
ISSUE 3**

## NORTH WEST REGIONAL MONITORING PROGRAMME NEWSLETTER

### Weathering the Storms in the North West

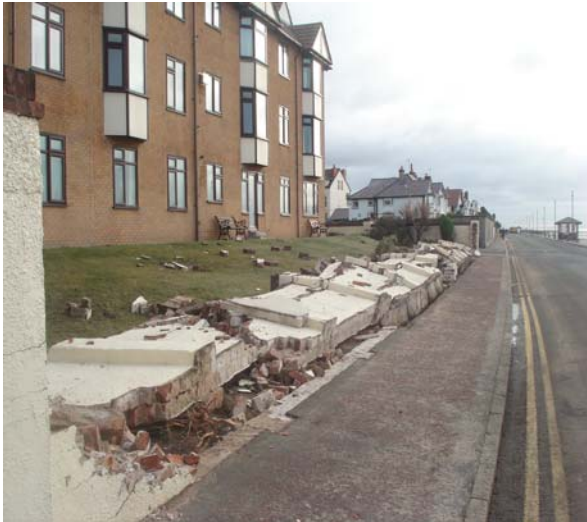
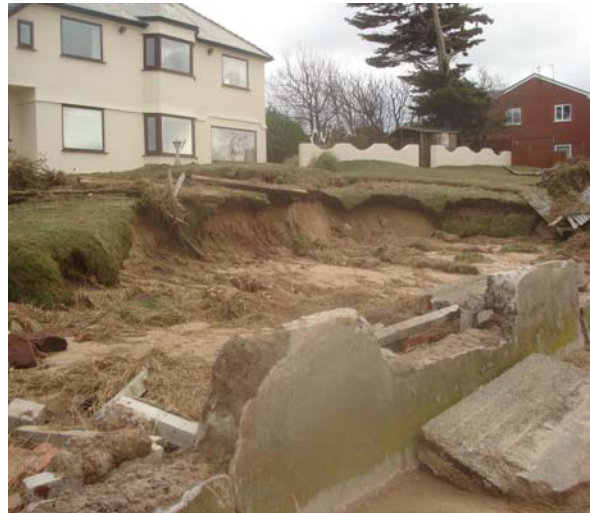
South Parade, West Kirby

At West Kirby, in the Dee Estuary, tide levels exceeded the crest of the sea wall with water flowing freely across the highway. This caused flooding to residential properties and damage to boundary walls. Properties fronting the foreshore experienced damage to boundary walls and erosion of gardens. Although there was minimal damage to coastal defences there was significant damage to council assets at South Parade. Promenade railings, benches, surfaces and shelters were all damaged along the entire length.

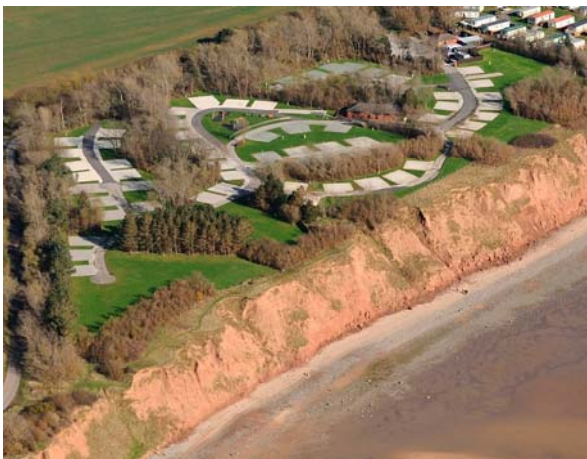
Thurstaston cliffs 2012

Tidal and weather conditions also caused erosion of clay cliffs at Thurstaston, south of West Kirby. The programme commissioned a set of oblique aerial photography for the region captured on December 16th. If you would like a copy contact us. Oblique aerial photography is a useful way of quickly assessing erosion. The impact of the December storm on the cliff can be seen when 2014 post storm photography is compared with photography taken in 2012.

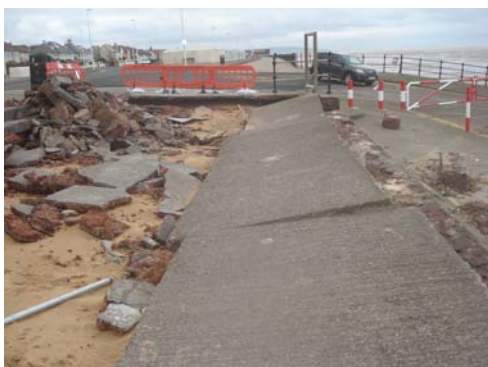
Meols Parade, Meols

At Meols, north Wirral, the seawall received superficial damage along the majority of its length, except for Sandhey Slipway where approximately 25 metres of sea wall coping was lost, the promenade surfacing was destroyed and the ground below the promenade was also washed out; however, this washout did not extend as far landward as the highway. Fortunately the integrity of the rest of the structure was not compromised. There were multiple locations along Meols Parade where promenade surfacing, steps and railings were damaged. At New Brighton flooding caused major disruption. The Fort Perch Rock car park was inundated with tidal waters from overtopping, the floodwaters reaching inland as far as Marine Promenade. **Photographs courtesy of Wirral Council.**

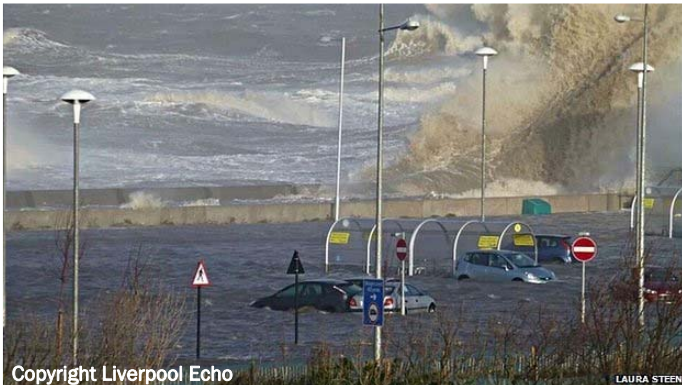
Copyright Liverpool Echo  
Kings Parade, New Brighton

At the storms peak, the crest of the inshore waves were at the same level as the crest of Kings Parade sea wall causing green water to overtop. This, however, was exacerbated by waves reflecting vertically on impact with the sea wall and the resulting spray being blown inland by the prevailing 70mph winds.

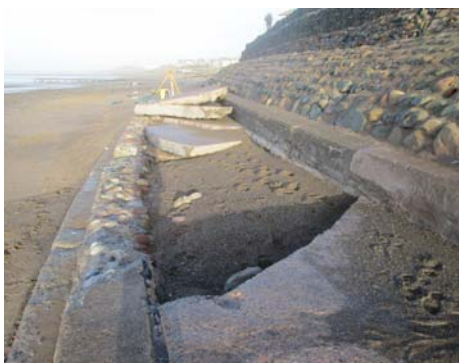
Seascale Seawall - Part of the concrete slab was ripped off during the storm on 3<sup>rd</sup> January. This is a Cumbria Highways structures and has been repaired. The surveyors are checking for movement in the bank behind the structure.

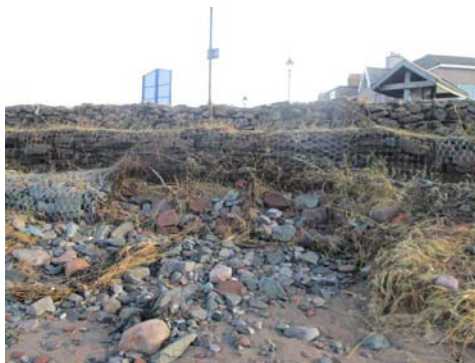
Damaged gabion baskets at Seascale. Rock armour has now been placed in front of these for protection.

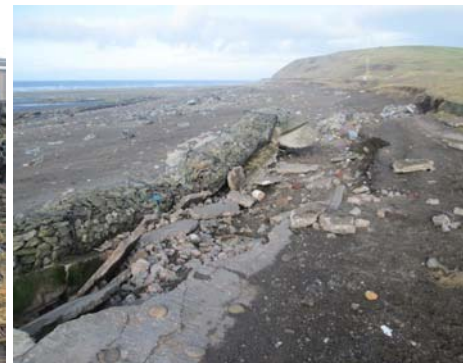
Damage to concrete plinth and gabion baskets at Parton. Due to access problems it was only possible to undertake a mass concrete pour to stabilise the area.

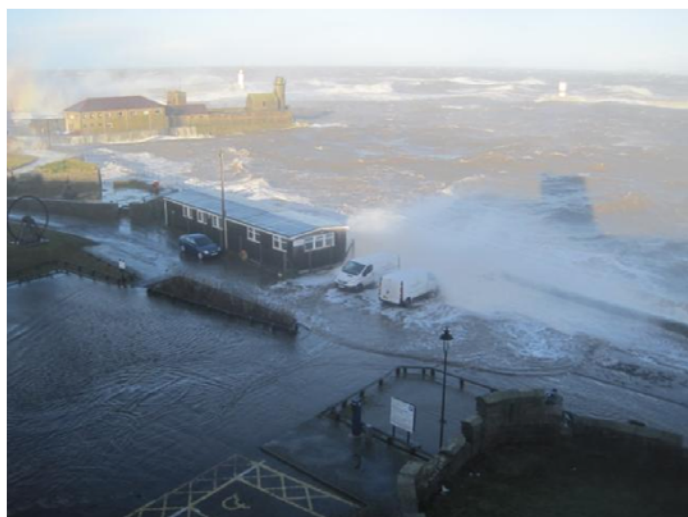
Whitehaven harbour damaged by storm surge and caused £300k of damage. No property flooding. Impacts could have been worse but the surge was lower than forecast and wind direction changed.

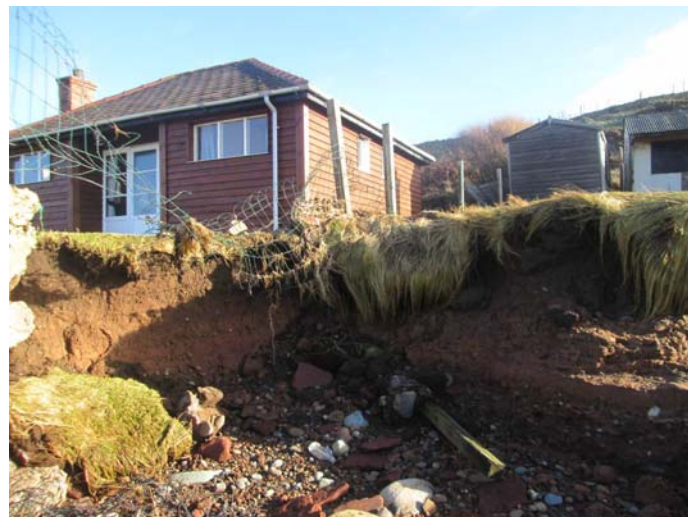
Damage behind defence at Seamill. The most interesting work was undertaken at St Bees promenade, where a sink hole appeared. However, this appeared to have been caused by the stream and not the sea .

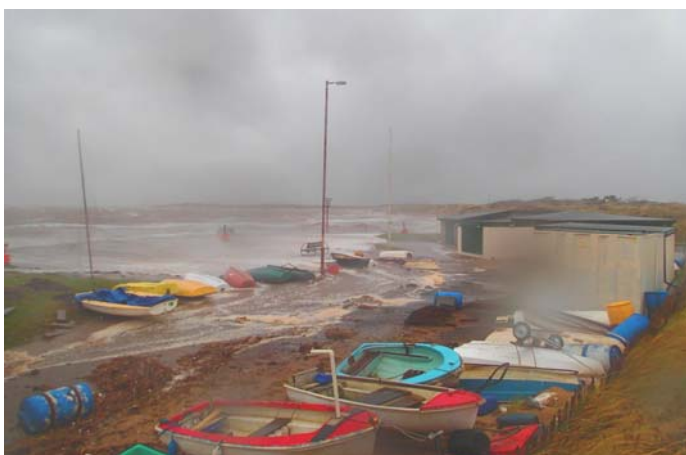
Fortunately no properties in Sefton experienced flooding except Hightown Sailing Club's Club House and boat yard. Parts of the sea wall and visitor car park at Crosby were damaged and the boardwalk at Formby was partly washed away.

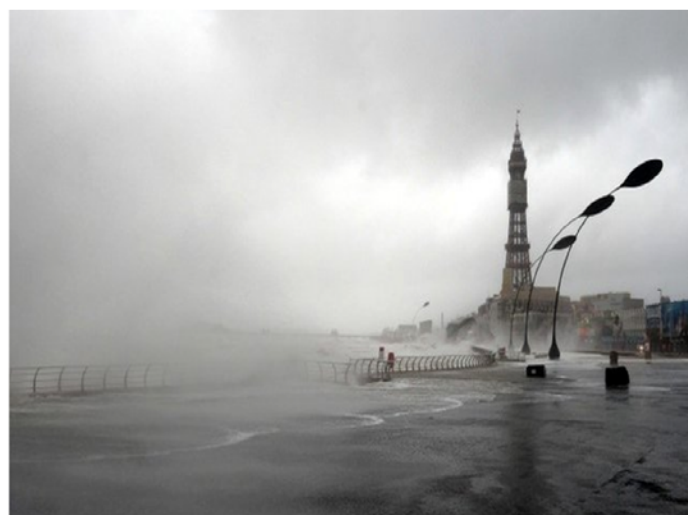
14 properties were flooded mainly in Blackpool, Fleetwood and Lytham. Flooding to several properties in Blackpool at North and Central pier from wave overtopping.

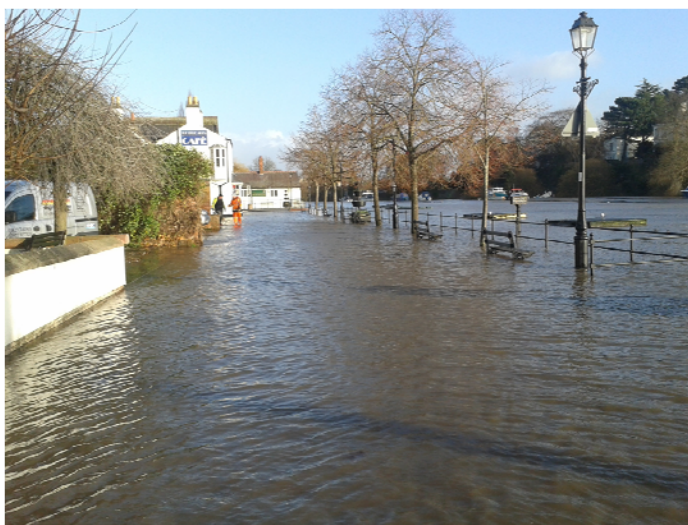
This picture is at The Groves and shows the boathouse pub flooded.

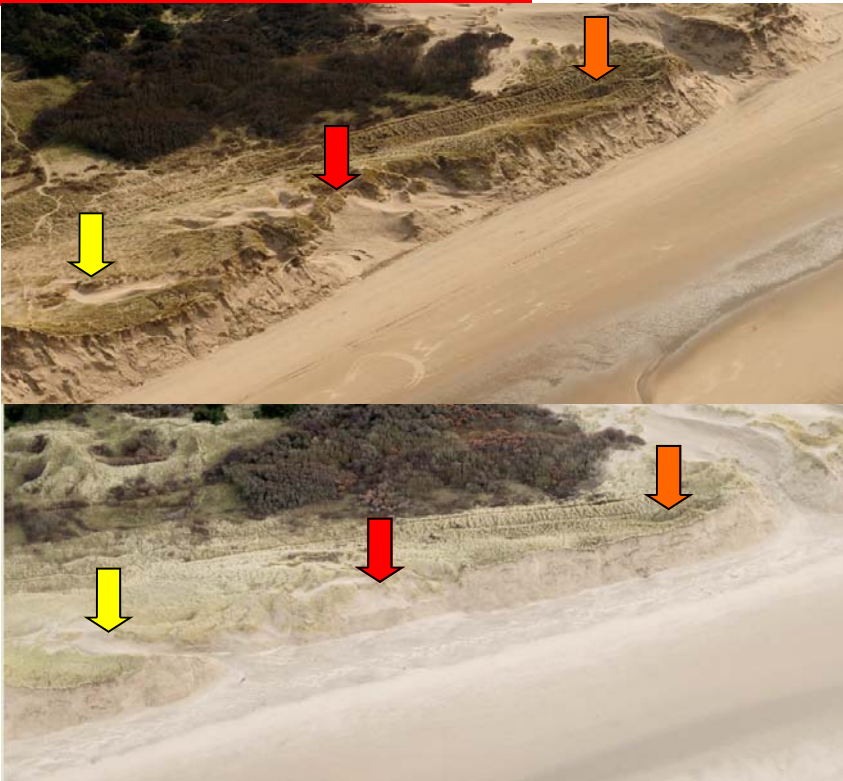
In response to the winter storms a number of surveys were commissioned to understand their impact. A coast wide oblique aerial survey took place on 16th December 2013. Left is a “before” image dated 16/03/2012 and underneath, one of the new obliques from 16/12/2013 which clearly shows large areas of erosion at Formby National Trust.

Comparing the area between the yellow and red arrow shows the largest area of erosion, the dune frontage has been cut right back to just under the long sand blowout and the dunes are now much steeper.

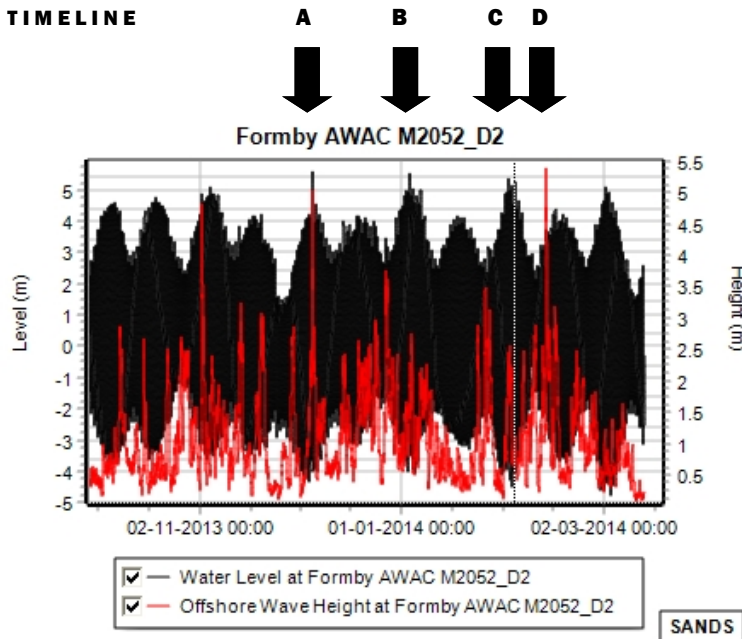
The graph from the AWAC data shows the water level mOD (black band) and the wave height m (red line). The event on the 5<sup>th</sup> December can be clearly seen where the water level exceeded 5.5m and coincided with waves over 5m. This combination of high water and large waves is the reason for the widespread flooding and damage. The event on the 3<sup>rd</sup> January had similar water level but no significant waves associated and as such the impacts were much less. The third event on the 1<sup>st</sup> February had a lower water level again of 5.29m and small waves. The highest waves (5.39m) in the period occurred on the 12<sup>th</sup> February but coincided with a lower water level and as such didn't have any significant impacts.
