**Figure 1: Management Unit 1B (Grain Village)**

## Survey Regime

## Summary of Beach Operations

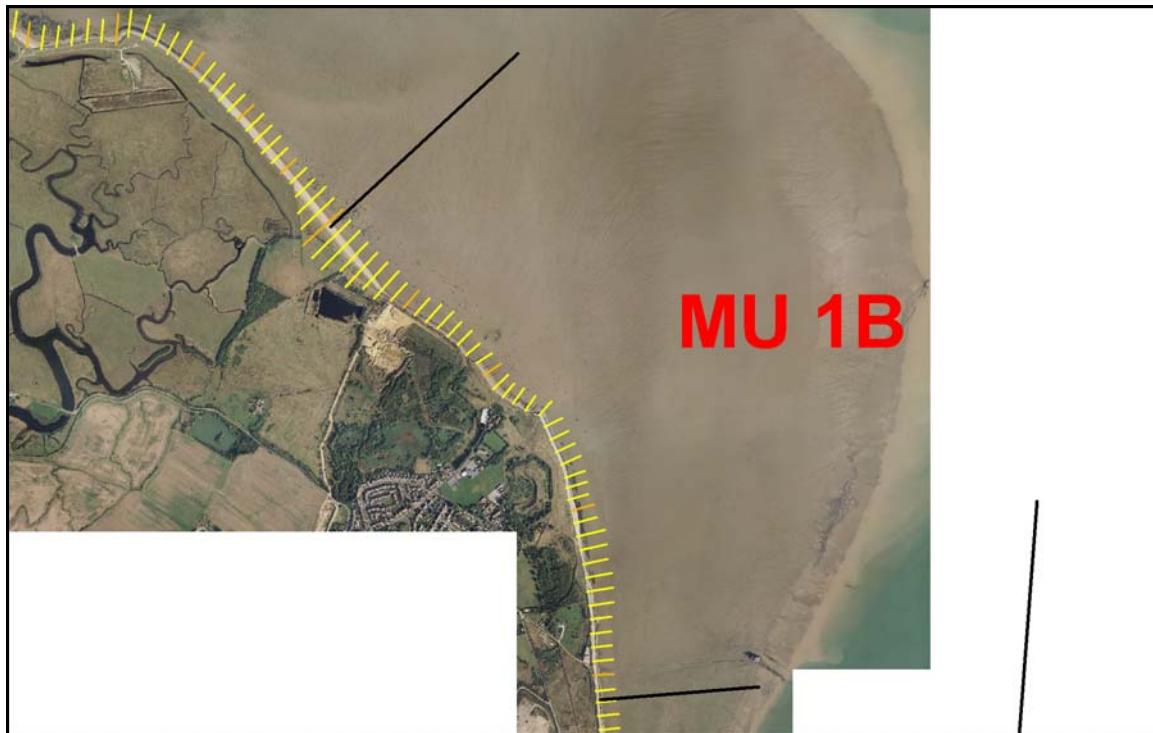
Blue: Recycling Extraction Point

Red: Recycling Deposition Area

Shingle beaches which front Grain Village vary in their ability to defend. The southern section of this management unit is characterised by a seawall. Towards the centre of the unit the defence changes to a derelict anti-landing site left over from WW2, which acts as a dissipative barrier between the cliff face and approaching waves. Areas in front of the embankments act as an effective defence, however further along the beach shingle is sparse. The main defence for the northern section of this management unit is the beach face itself, backed by a raised bund. The beach has several timber groynes to add to the protection of the beach as this section is prone to erosion. The approximate beach gradient is 1:9 for this section of coastline. Mud dominates the lower foreshore with small areas of salt marsh interspersed across the foreshore.

There have been no recycling or replenishment schemes within this management unit since monitoring began in 2003.
