Figure 1: Management Unit 5D (Bishopstone)

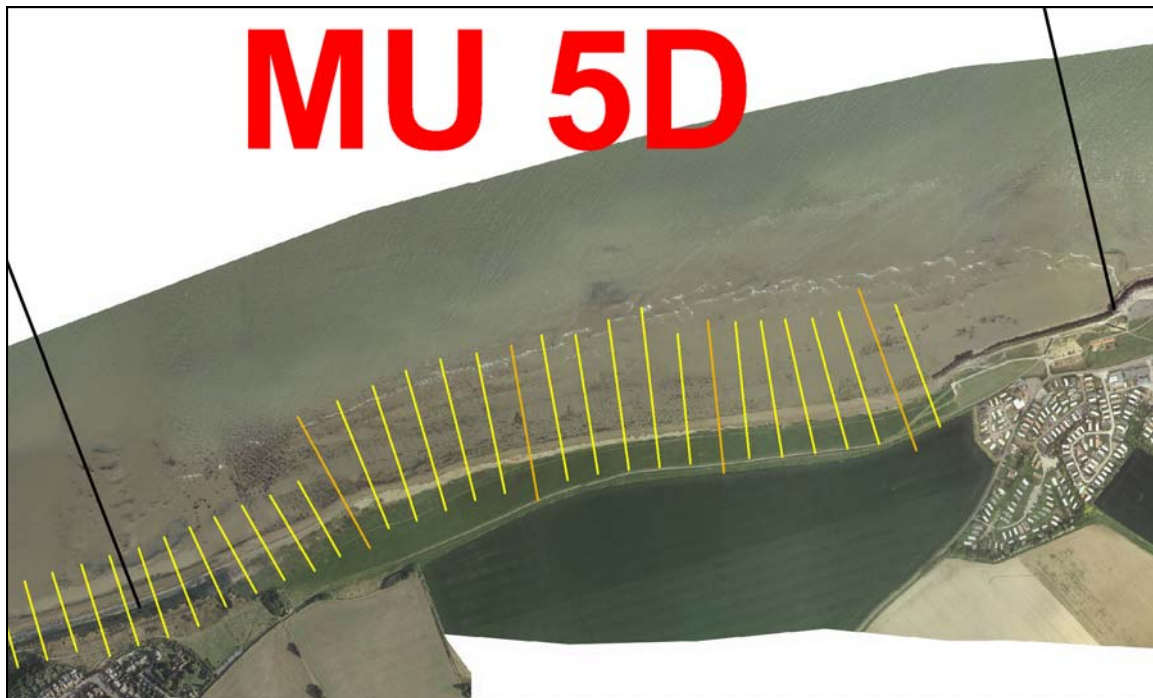
Blue: Recycling Extraction Point

Red: Recycling Deposition Area

Management Unit 5D is currently an undefended stretch of coastline, backed by sandstone and clay cliffs, the cliffs range between 3m and 15m in height. The main beach consists of a narrow sand and gravel beach, fronted by a wide wave cut platform. This comprises of sand and rocks of varying sizes. The slopes are prone to minor slope failures and landslides. Development along this frontage is minimal, and in most cases the built assets are set back from the cliff face.
