Figure 1: Management Unit 6B (Margate)

This management unit encompasses the town of Margate and the protective structures fronting it. The current defences include the seawall and promenade directly in front of Margate, however the pocket beaches have no primary defence other than the beach itself. The harbour arm impedes sediment movement alongshore, of which the sediment supply is already low and the shoreline is held seawards of its natural alignment. Narrowing of the beach and intertidal areas are anticipated in the near future (Isle of Grain to South Foreland SMP, 2007).

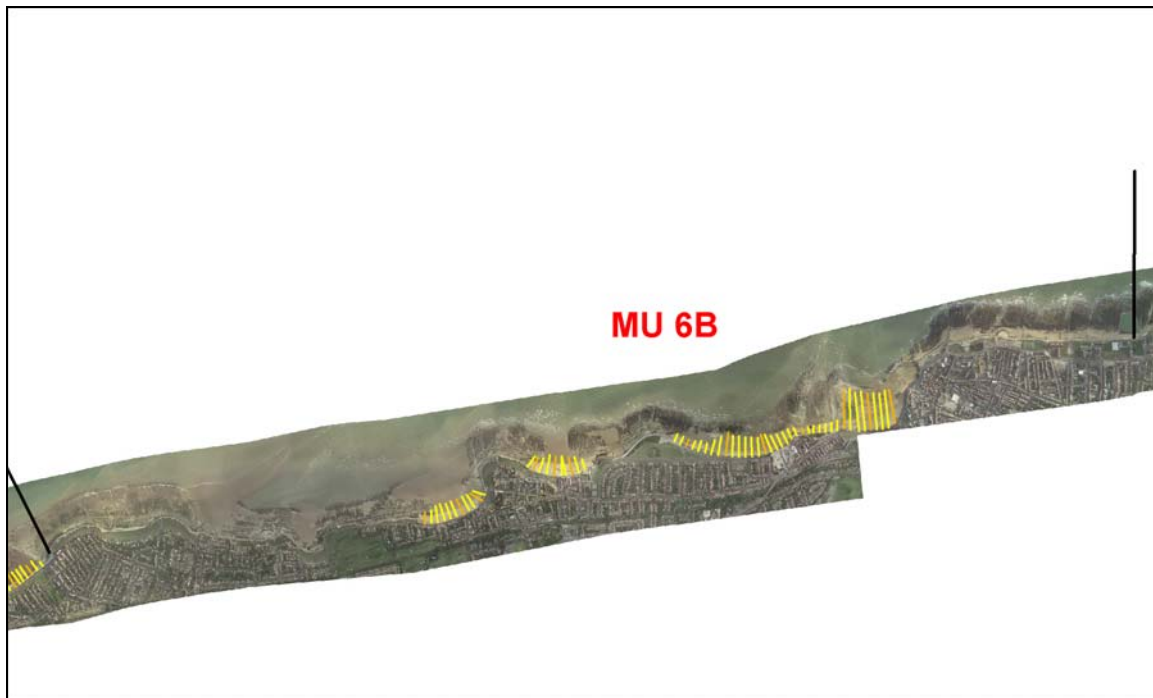
*Blue: Recycling Extraction Point*
Red: Recycling Deposition Area

No replenishment or recycling activities have been undertaken within this management unit as longshore drift is minimal; a result of the pocket beaches. Beach profile regrading has been undertaken to increase natural beach protection, however no additional material has been added or removed. Subsequently, significant amounts of beach nourishment will be required if an amenity beach is to be maintained in the latter epochs.
