Figure 1: Management Unit 15 (Jury's Gap)

Jury's Gap is a low lying frontage backed by infrastructure at the western end. Between The Suttons and Jury's Gap the narrow backshore is protected by a concrete seawall at both ends of the frontage and a shingle bank along the whole length with timber groynes. The beach is predominantly mixed shingle sand, with a sand foreshore.

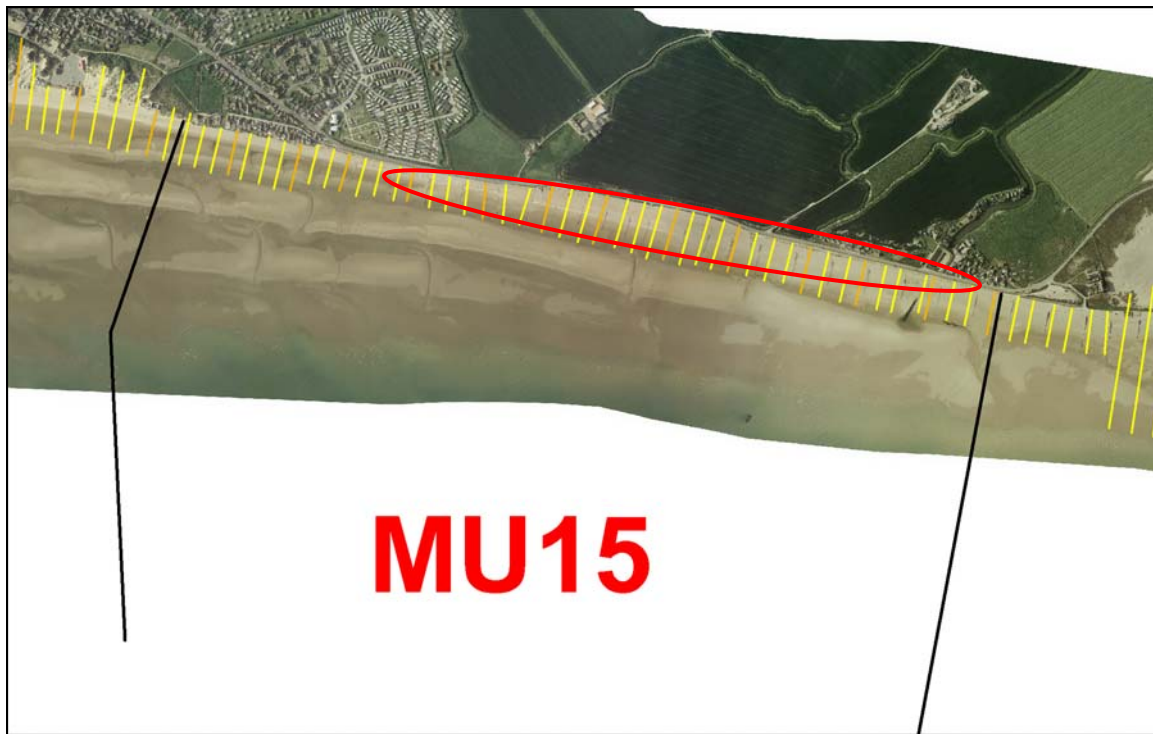
Blue: Recycling Extraction Point
Red: Recycling Deposition Area

Date	Operation	Quantity (m ³)	Location/Notes
2009			
May	Programmed Maintenance	48,000	Deposition between Profiles 4c00938 & 4c00985
2008			
April	Programmed Maintenance	27,000	Deposition between Profiles 4c00938 & 4c00985
