Policy Unit: 5f PHB13

Parkstone Yacht Club to Salterns Marina

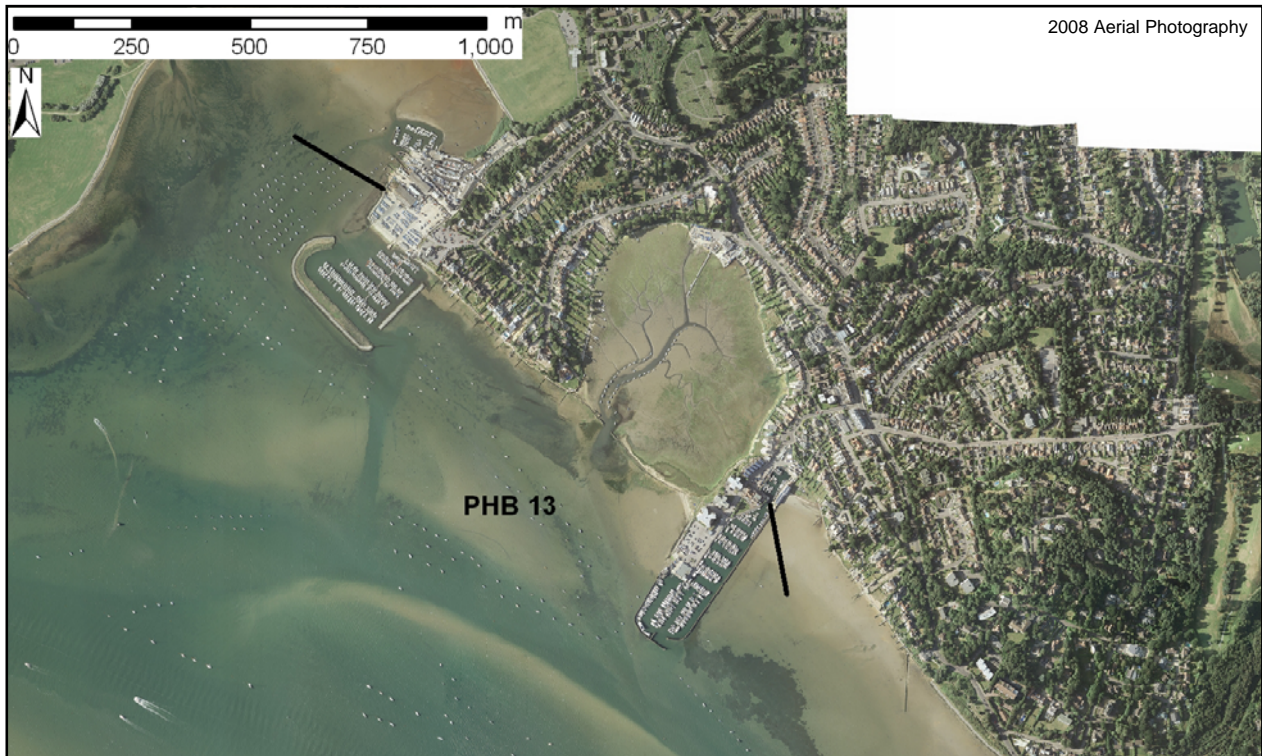
This unit is heavily defended with various walls and revetments along the entire coastline, protecting both of the marinas and local property. The lagoon is protected by a seawall, behind which there is a large expanse of vegetated estuarine mudflats backed by walled defences. The foreshore of sand and mud decreases in width to the north of this unit reducing the protection afforded by it. This is a relatively low energy environment which is largely considered to be stable. The biggest threat facing this management unit is from tidal flooding and a breaching of the lagoon seawall.
